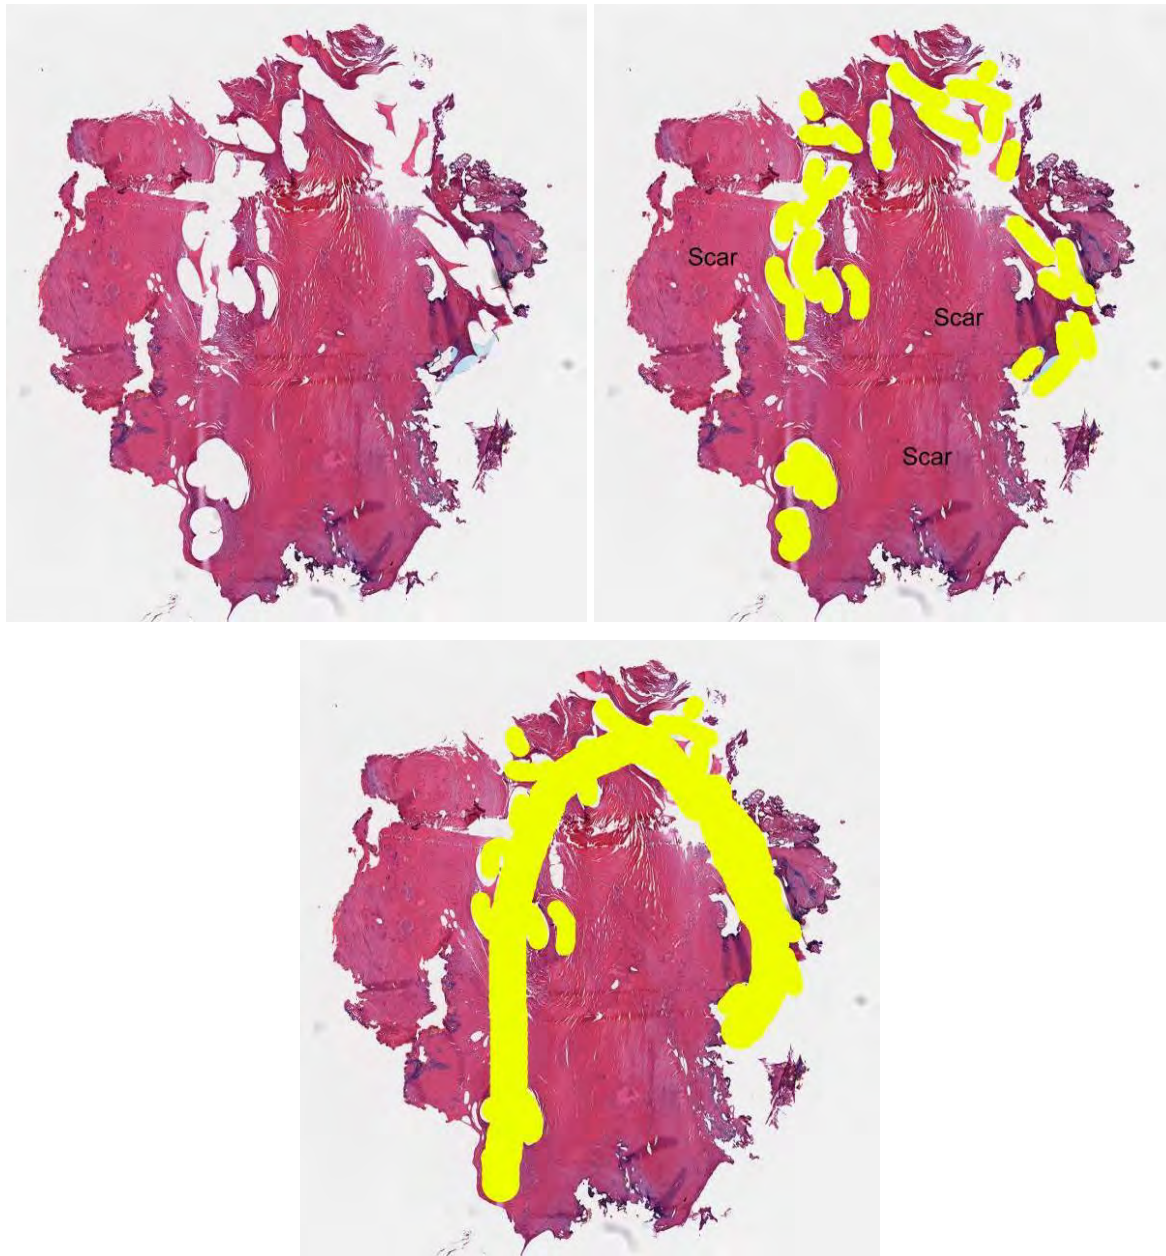
Figure set 10c. A TVT sling with curled edges, H&E, 2.5x.

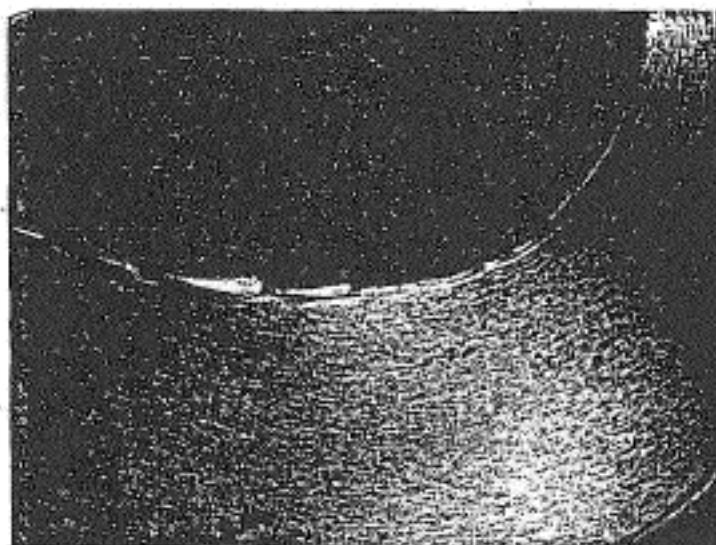
Figure set 19e. Image from the 1983 Ethicon study.

Figure 5 - Histological longitudinal sections of PROLENE from sample 6, block A, Phloxine stained. A 3.0-4.5 micron cracked surface layer is birefringent when viewed with polarized light, magnification x300.
